# Archaeological Investigations at Móakot 2019

## *Progress Report*

**Háskóli Íslands  
Reykjavík 2020**

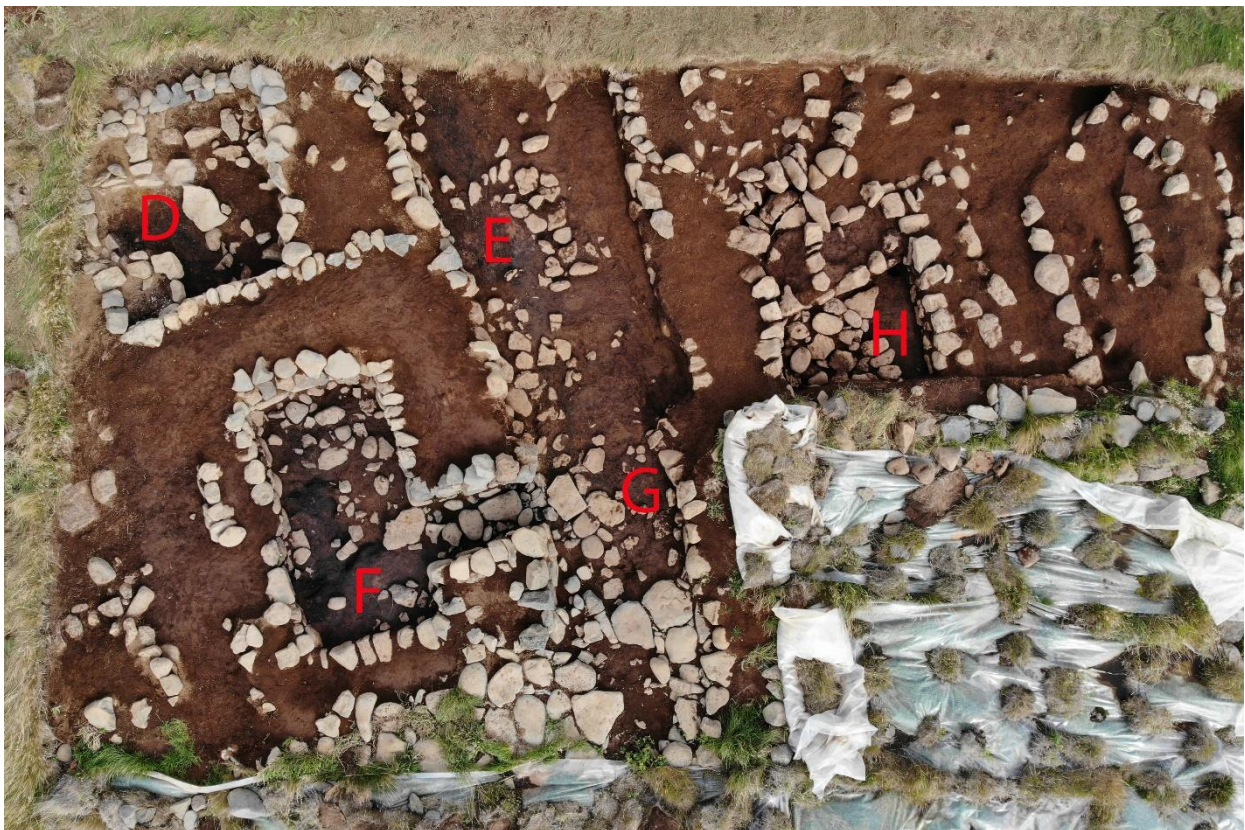
Figure 1. Overview of 2019 excavation area. Rooms are identified with letters. /Yfirlitsmynd af uppgriftarsvæðinu 2019. Rýmin eru einkennd með bókstöfum.

including the removal of a floor levelling layer/foundation ([94451] & [94969]) and under that was found a black, charcoal-rich midden which spread out under the floors and walls of Structure F and continued north into the space under Structure D and west under (unexcavated) external rubble and collapse. A patch of peatash [94865] lay over this charcoal layer and could be part of the same midden but also may be contemporary with Structure F as it seems to infill a possible hearth. The underlying midden will not be investigated further but it does point to earlier activity in this part of the site which may also be associated with a turf wall found in 2018 under Structure D. The main focus of investigation in 2019 otherwise concentrated on the area to the east of Structures D and F, including a linear space separated into a north and south part by a turf wall – designated as Structures E and G respectively. In addition, the area to the east of E and north of A was investigated, resulting in the discovery of another new building, here designated as Structure H (fig. 1).

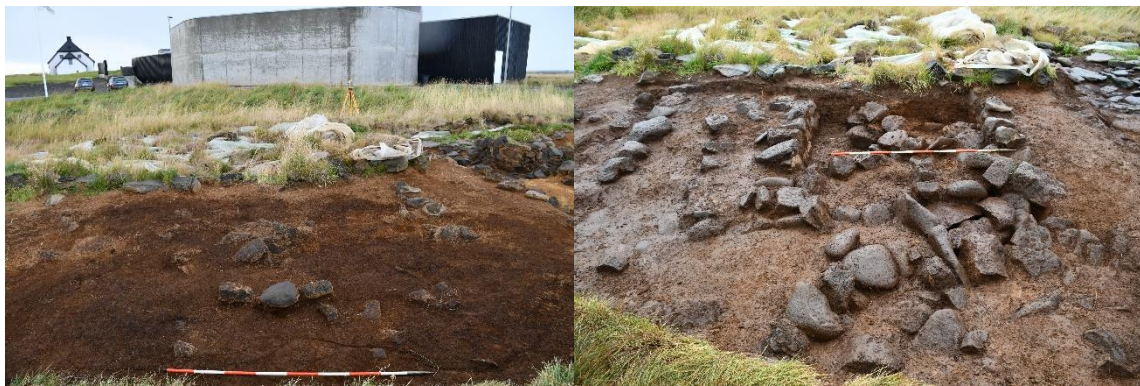
*Figure 3. Structure H before (left) and after (right) excavation; facing south / Mannvirki H fyrir uppgröft (vinstri) og eftir (hægri). Horft til suðurs.*

This structure was exposed for the first time in 2019, though indications of its presence were evident from soil discolorations and fragmented wall lines. The building lies both north of and under the later Structure A; only the northern section outside of A was investigated in 2019. After removal of some dark soil [93418] and some turf debris ([93904], [93767], [94133]), the outlines of the structure became clearer (fig.3).

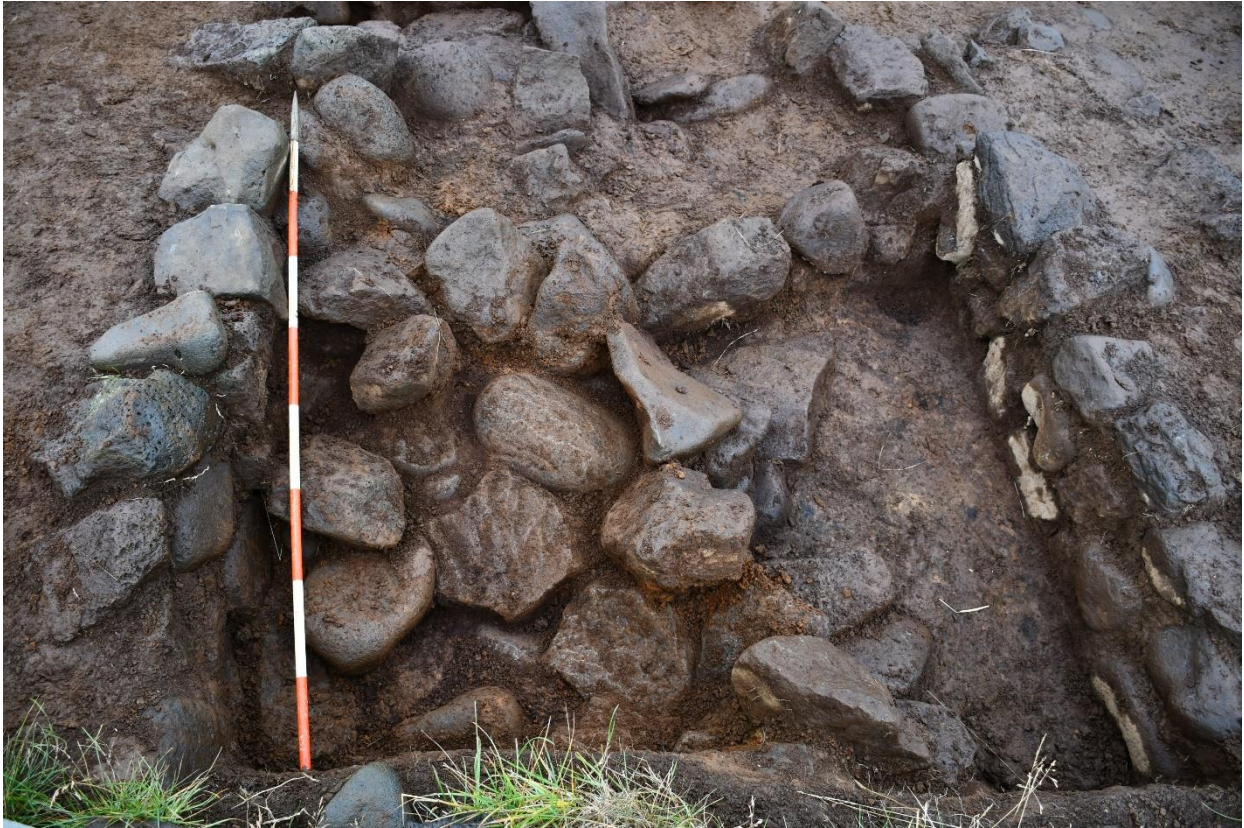
Figure 4. Detail of the interior of Structure H showing stone rubble over a possible stone floor; the postpipe is in the top right corner; facing north / Horft inn í mannvirki H þar sem sést grjóthrun yfir mögulegu hellulögðu gólfi, stoðarhola er efst í hægra horni. Myndin er tekin í norður.

There were two walls running north-south defining a narrow space c.2m wide. Inside, it was infilled with turf debris ([986213]), and near the base, a substantial pile of stones [115] lay between the walls, continuing south under Structure A, some of which may be part of a cobbled floor (fig. 4). The northern end of the building was very badly disturbed but lower down there did appear to be a continuous wall, though it was a clearly a later addition as it was abutting both the east and west walls. A postpipe and fill ([96669]/[96884]) was also excavated, marking the location of a post in the northeast corner that was probably removed after the building had collapsed. Possibly the structure had originally had a wooden gable end at the north side. Most of the structure

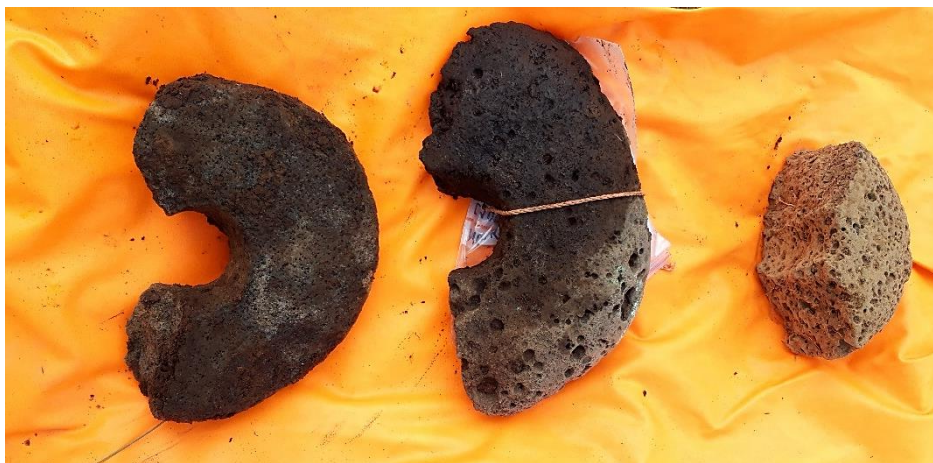
*Figure 5. Three out of five fish hammers from the 2019 season / Þrjár af þeim fimm fiskisleggjum sem fundust við uppgröftinn 2019.*

fragments of copper sheet, a pin, strip and possible button or stud. In many ways the most diagnostic artefacts were those in stone; these included two fragments from whetstones, five stone (fish-) hammers, a net-sinker, and a possible oil lamp or unfinished stone hammer. All the ceramics were glazed redwares, probably from cooking vessels while the single glass fragment was from a green bottle or flask. The glass came from the turf wall [93889] and indicates a date probably no earlier than the 17<sup>th</sup> century. Most of the pottery came from Structure F where several other fragments were recovered in 2018. It is hard to date but future analysis of the whole assemblage will hopefully be able to yield more information.
