# ÓLAFSDALUR 2018

## AN INTERIM REPORT/FRAMVINDUSKÝRSLA

Howell Magnus Roberts & Birna Lárusdóttir

**FS731-18121**

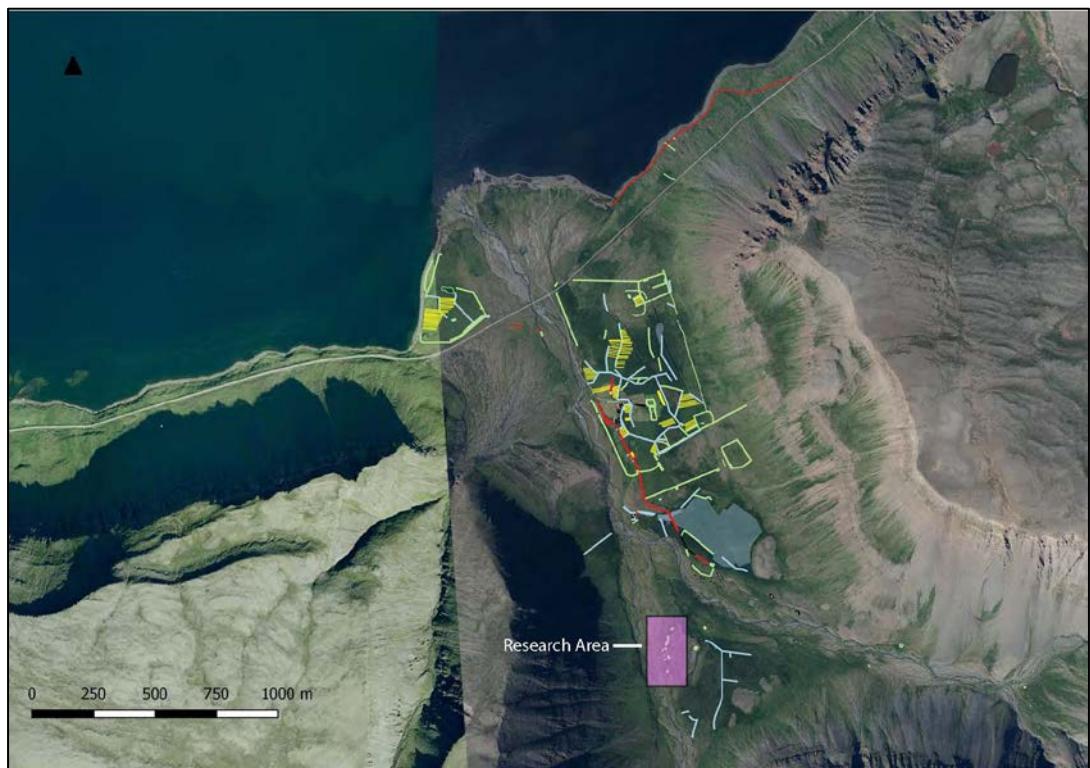
**Figure 2 – Research Area, shown in pink & surveyed archaeological features  
(see Birna Lárusdóttir 2018b)**

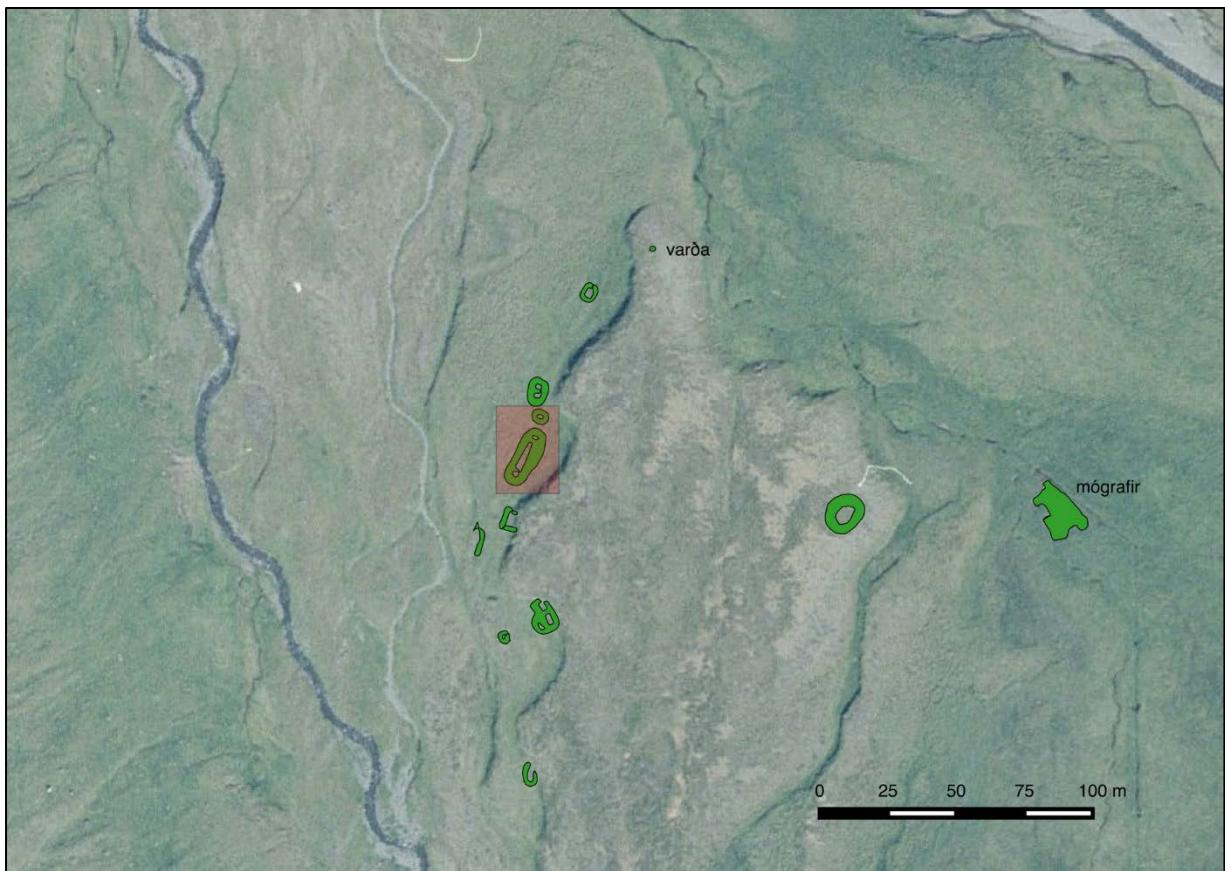
**Figure 3 – Structure 1, within pink box and nearby remains (based on records from Birna Lárusdóttir 2018b)**

It is intended that the main sequence of internal occupational layers will be excavated in 2019, and additional external structures and deposits tested and evaluated in 2020. At least 10 additional ruins are located in the immediate proximity of the excavated area (see Figure 3). The date and function of these awaits further clarification.

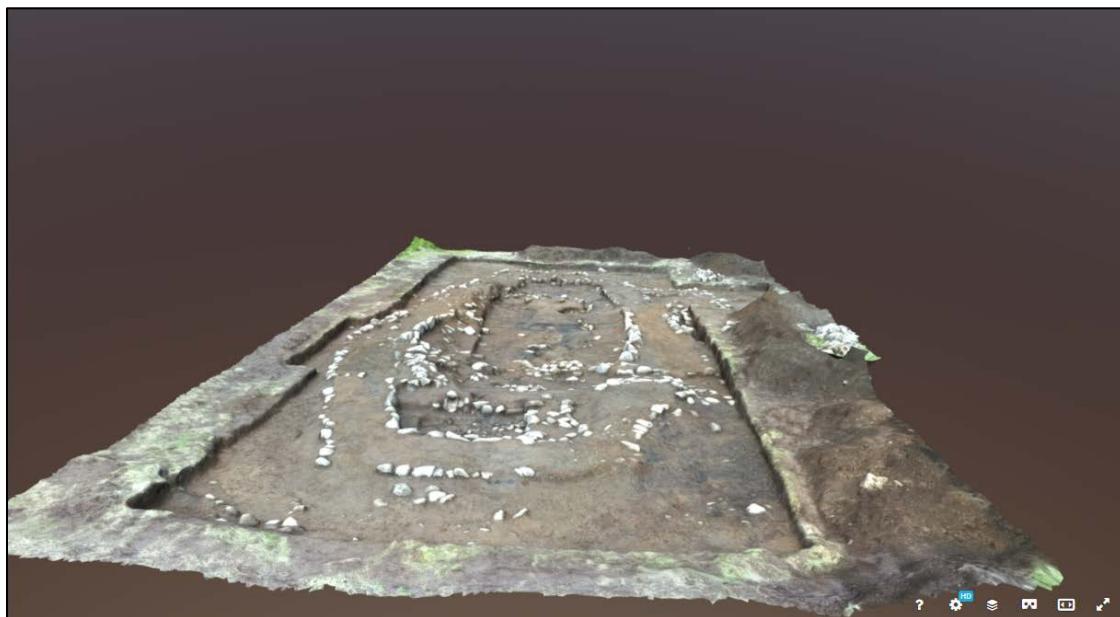
**Figure 4 – 3d model of excavated structures (see  
<https://sketchfab.com/models/98e9308d19234275b2b6ef976973d406>)**

After the removal of turf, topsoil and sterile naturally deposited overburden, excavation proceeded by means of Single Context Planning. A 5m grid square system was established using a Trimble S6 Total station theodolite, with fixed points located using a Trimble GeoExplorer 6000 series GPS. All subsequent deposits were hand-drawn and recorded at a scale of 1:20 using pro-forma recording sheets. These records were supplemented by digital photography (using a Nikon D3200 DSLR with an 18-105mm zoom lens), and by drone photography using a DJI Mavic Pro. Drone photography was processed for 3d modelling using Agisoft Photoscan, and published on the internet in Sketchfab (see Figure 4).

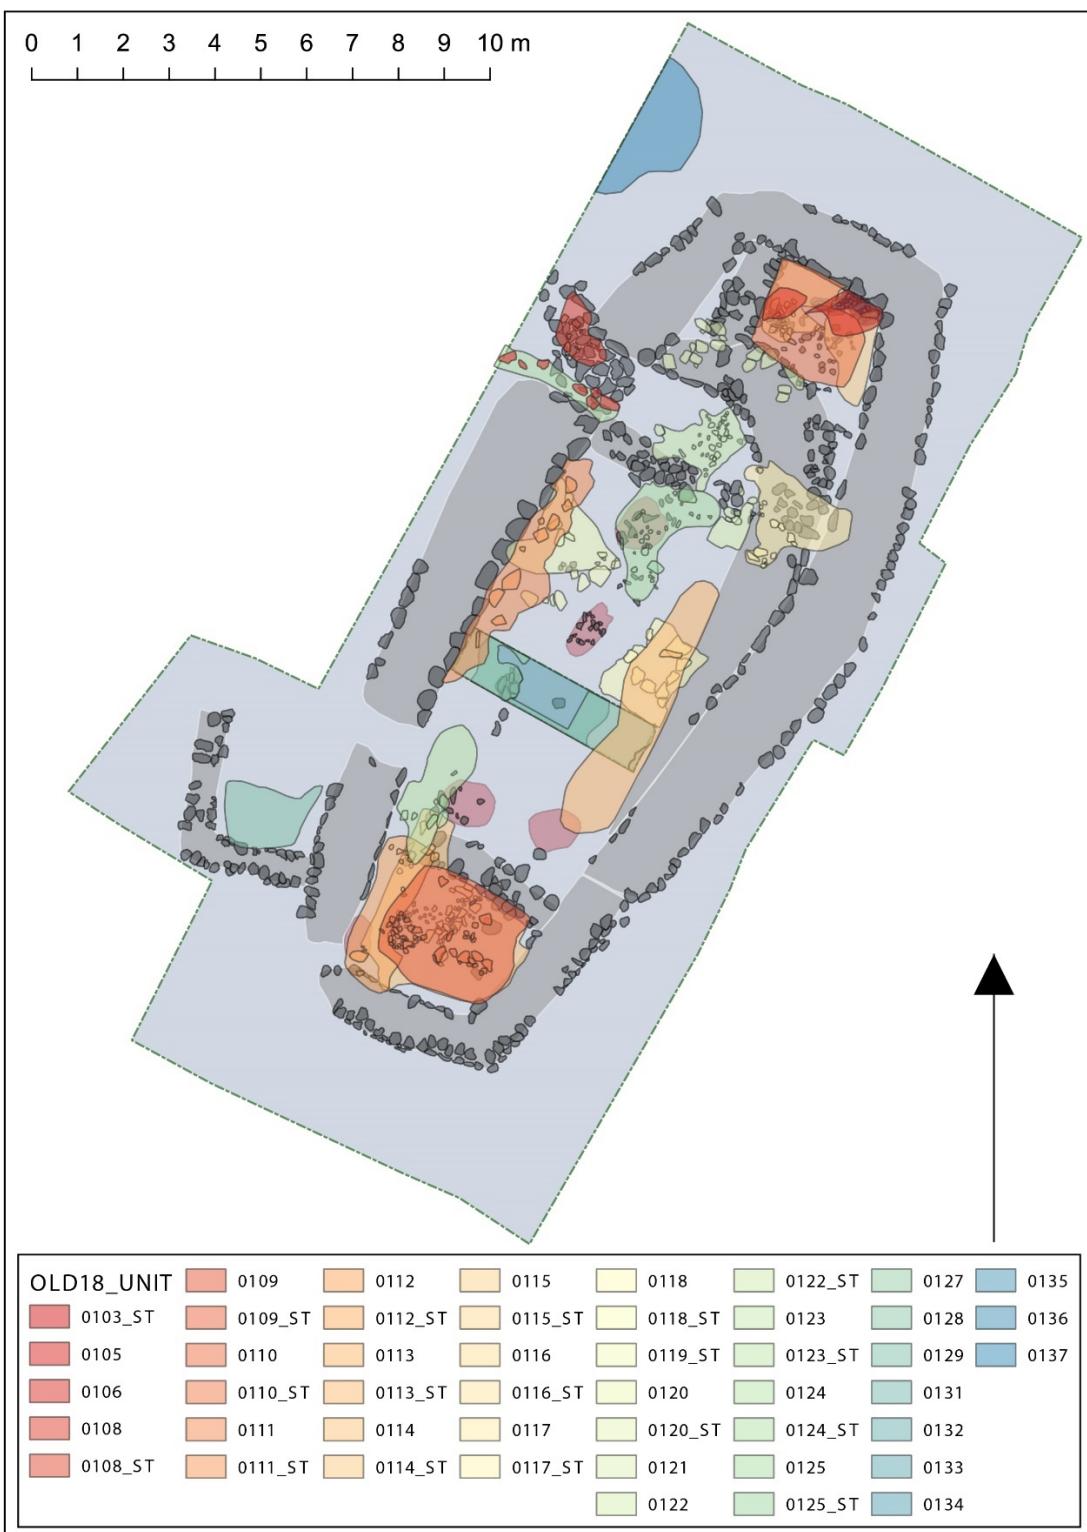
**Figure 5 – Excavated Contexts**

proceeded to the surface of the floor layers, as a guide to their depth and preservation. Most of the artefacts recovered during the 2018 season were found in collapse deposits, with the exception of two nails and a knife recovered from the floor deposits in the 2017 trench. For further detail see table 1, figure 5 and appendix 1.

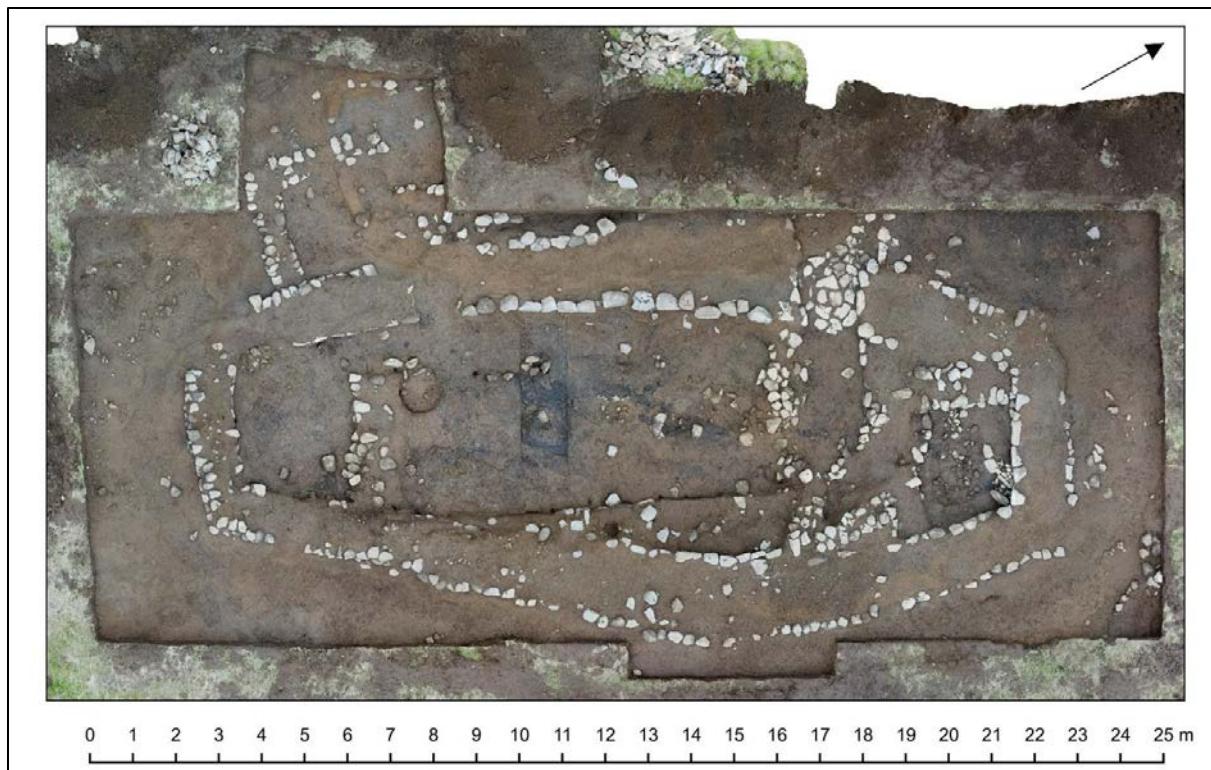
**Figure 6 – Vertical drone image of the site after excavation**

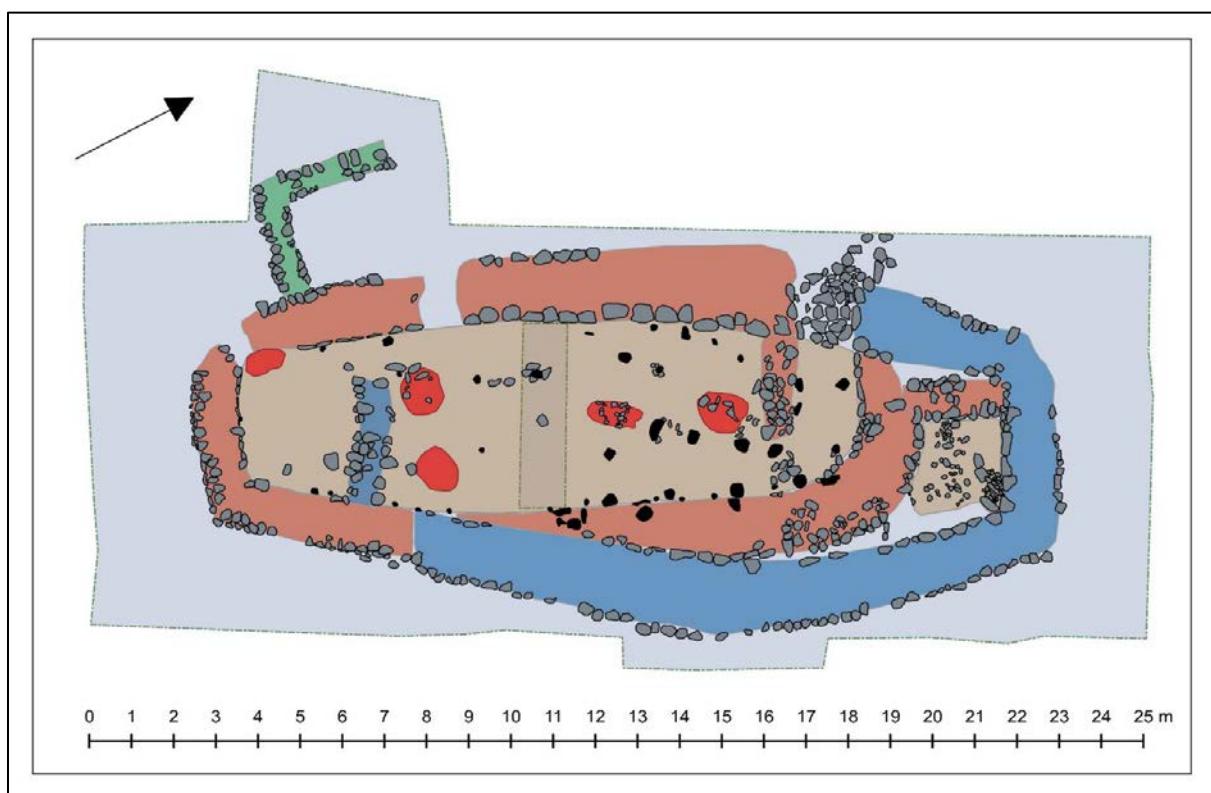
**Figure 7 – Primary unexcavated features (colours indicate possible structural phases)**

The emphasis of the 2018 season was on removing post abandonment deposits, so there is little scope for interpretation of the archaeology at this stage. The structural remains were clearly visible at the end of the season, and some observations can be presented. The preservation of the structural remains is highly variable. The ruin sits beneath a high bank to the northeast, whilst the southern and western parts of the building are much more exposed to the wind and weather. This is thought to account for the much better preservation of the northeastern wall which stands to a height of up to 1m and approaches 2m in width. It is clear from the extent and alignment of the wall remains and apparent floor surface that several phases of construction and occupation can be expected. Figure 7 shows the site as it was at the end of the 2018 season, with possible interpretations of phasing presented in different colours. Several internal features were also noted, the aforementioned oven, a longfire, possible barrel pits as well as post-pads –holes and –settings. These features await further investigation during the 2019 season.

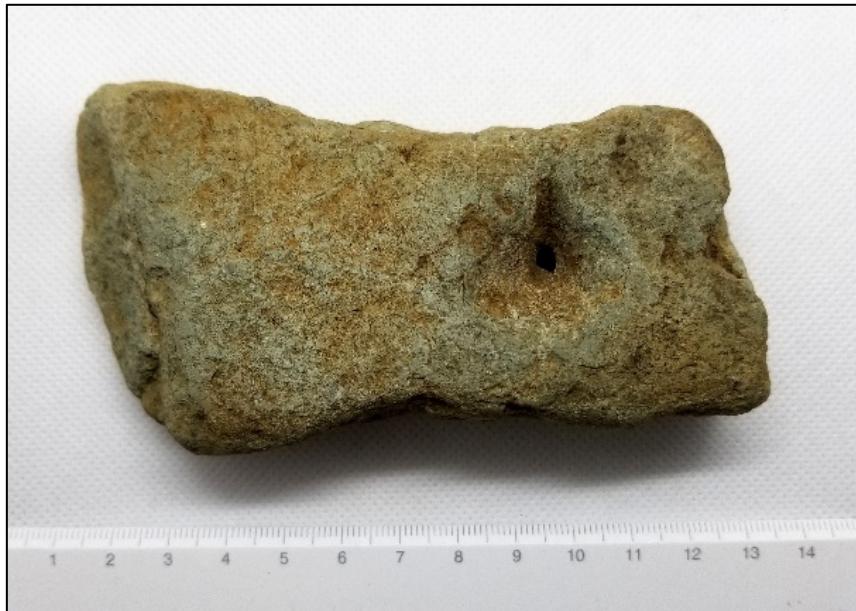
Steinn með gati OLD18-014

Rannsóknin er nýhafin og þær vísbendingar sem gripirnir gefa eiga eftir að taka á sig mynd. Naglar og rónaglar eru flestir, eða nú talsins og fundust einkum í veggjahruni og eru því sennilega með einhverjum hætti tengdir timburverki í byggingunni. Þá fannst lítt hnífur, OLD18-007, með heilu blaði og leifum tréskrafts, alls 4,92 cm að lengd. Bakki hnífsins er örlítið íhvolfur og sveigist eggin upp að hnífsoddi. Þessi hnífagerð er fremur óvanaleg og þekkjast fá dæmi um íhvolfra bakka, sé t.d. litið til hnífa sem hafa fundist í víkingaaldarminjum í York í Englandi, en helst kemur til greina gerð B (Ottaway 1992, 559,652). Hnífar voru nauðsynjaverkfæri og eru fremur algengir fornleifafundir. Meðal gripanna er einnig heilt lóð úr mjúkum grænleitum steini, OLD18-014, sem fannst í gólfí norðan sáfars í suðurhluta skálans. Steininn er ferhyrndur og flatur í þversniði, 11,2 x 6,2 x 2,5 cm stór. Gat til að þræða í er nálægt öðrum enda og fyrir gatinu hefur greinilega verið hoggið báðum megin frá en sjálft gatið er lítið, aðeins um 0,45 cm í þvermál. Steinar með gati voru til margra hluta nytsamlegir og erfitt að ákvarða hlutverk þeirra er þeir finnast stakir. En stundum má sjá að reynt var að velja steina með flötu þversniði í uppistöðuna í vefstaðnum til að steinarnir lægju betur saman. Ekki er því ósennilegt að OLD18-014 sé kljásteinn.

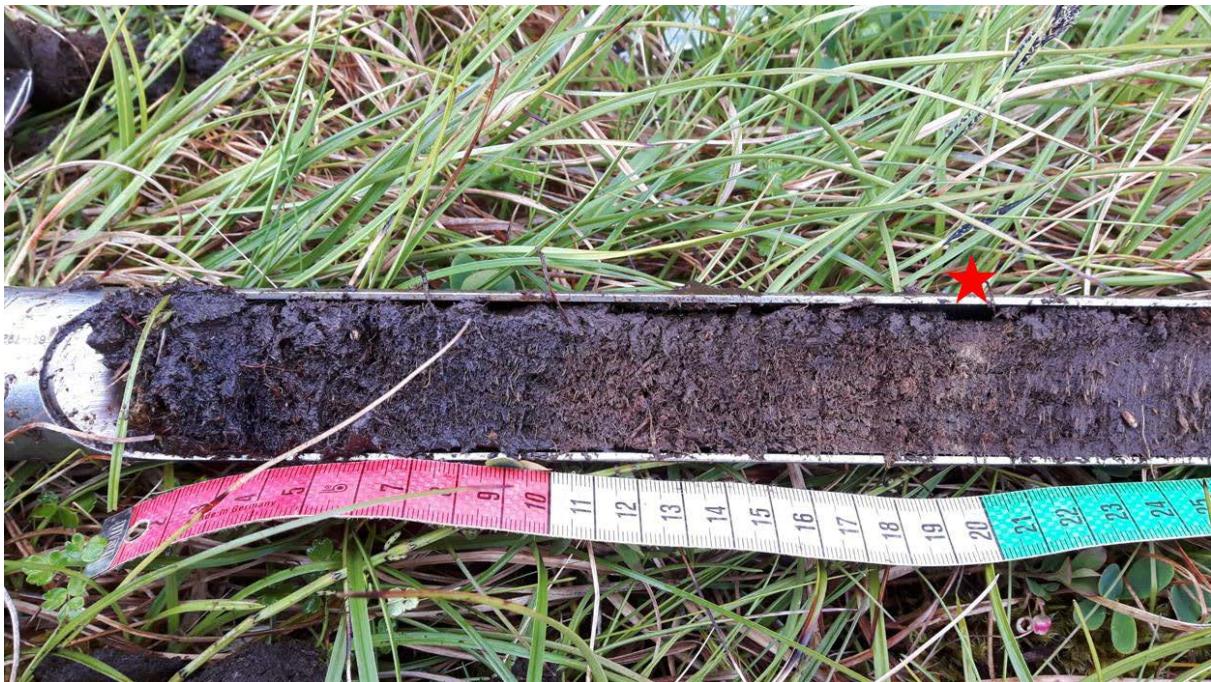
Prufubor með sniði sem innheldur meinta landnámsgjósku

Möguleikar til uppbyggingar aldurslíkana eru, að því er virðist, nokkuð góðir. Ofarlega í jarðvegssniðunum má finna dökkt gjóskulag, að líkindum frá 1693. Þá mátti á allnokkrum stöðum finna landnámsgjóska frá um 877. Á einum stað fannst einnig ljós, grófkornótt gjóskudreif fáeinum sentimetrum neðan við meinta landnámsgjóska sem að líkindum er Snæfellsjökull 1 (Ssn 1) sem er fáeinum öldum eldri en landnámsgjóskan (AD 300-500). Sýni voru tekin úr þessum gjóskulögum og verða þau efnagreind við Jarðvíssindastofnun HÍ á næstu mánuðum. Þau snið sem skoðuð voru reyndust afar rík af lífrænum leifum sem henta til aldursgreininga með kolefni-14. Lífrænn jarðvegur, mórvatn, bendir einnig til góðra varðveisluskiðryða frjókorna og fræja og því virðast allar forsendur fyrir fornumhverfisrannsóknir vera fyrir hendi. Að því sögðu bar mikið á að jarðlög væru röskuð (sem einnig má greina á loftmyndum). Á allnokkrum stöðum voru siltlinsur í jarðveginum sem kunna að benda til torfskurðar án þess að ummerki um slíkt sjáist á yfirborði. Mikilvægt er að huga að þessu við sýnatöku og þar koma umrædd gjóskulög að góðum notum.

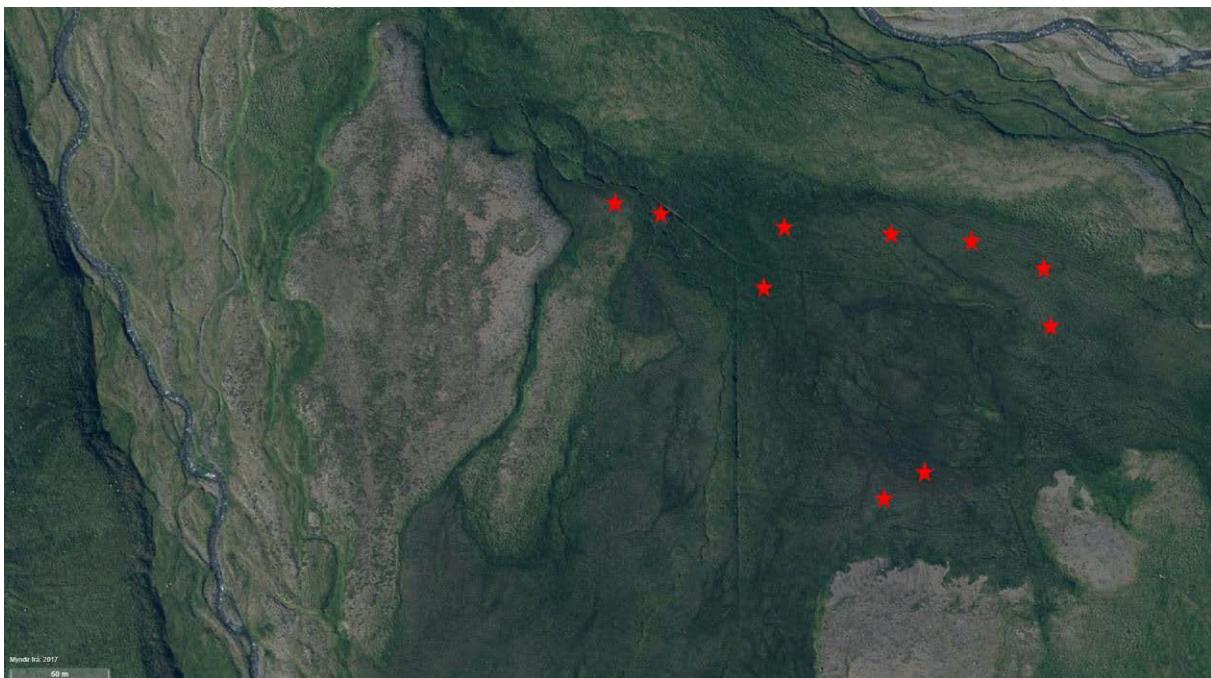
Yfirlitsmynd sem sýnir gráflega hvar borað var eftir mósníðum í þessari könnunarferð

Pann 3. júlí 2018 fóru Egill Erlendsson og Scott Riddell í Ólafsdal og gerðu forkönnun á möguleikum til fornumhverfisrannsókna í tengslum við rannsóknir á fornminjum og menningarlandslagi í Ólafsdal. Á þessu stigi er verið að grafa upp skála, að öllum líkindum frá landnámsöld innarlega í Ólafsdal. Könnun þessi náði aðallega til nærumhverfis skálans (sjá yfirlitsmynd).

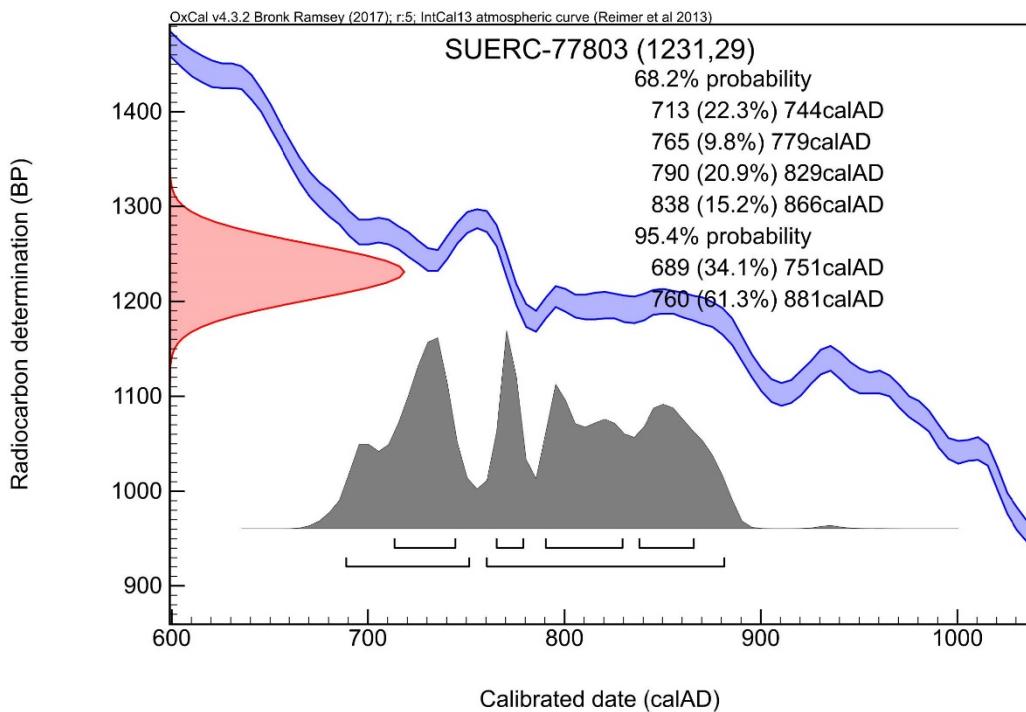
The radiocarbon age given overleaf is calibrated to the calendar timescale using the Oxford Radiocarbon Accelerator Unit calibration program OxCal 4.\*

The above date ranges have been calibrated using the IntCal13 atmospheric calibration curve†.

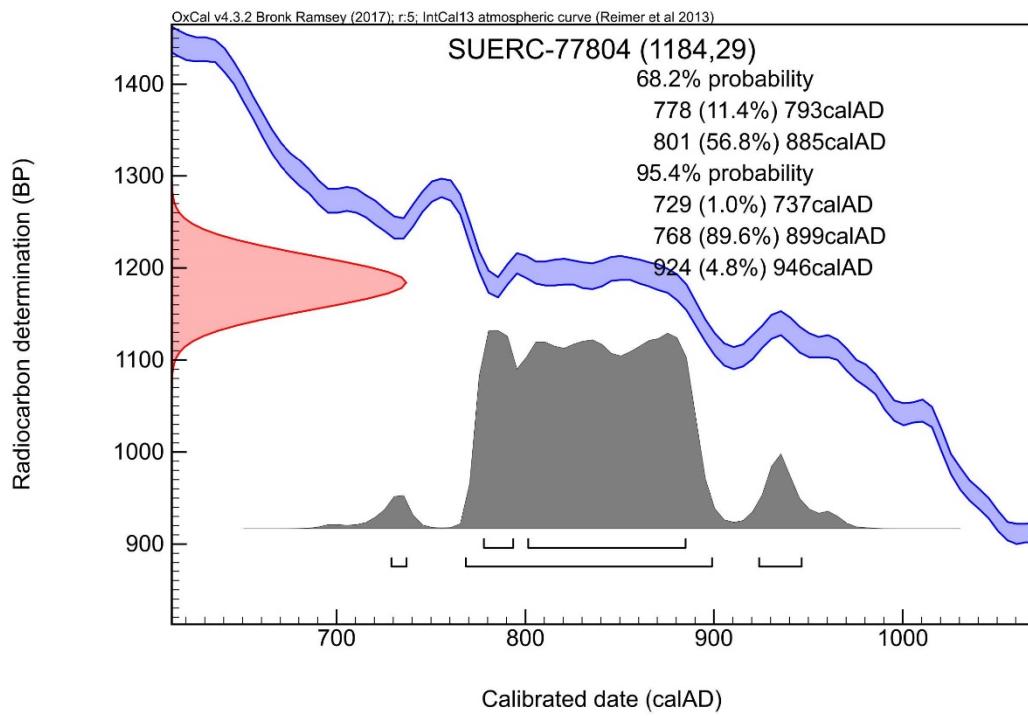
The radiocarbon age given overleaf is calibrated to the calendar timescale using the Oxford Radiocarbon Accelerator Unit calibration program OxCal 4.\*

The above date ranges have been calibrated using the IntCal13 atmospheric calibration curve†.
